External Strengthening of High Density Steel Tank HJ3 Carbon Fiber

Case Study – HJ3 CS200908

External Strengthening of 2.5M Gallon Steel Tank with HJ3 Carbon Fiber

Case Study – HJ3 CS200905

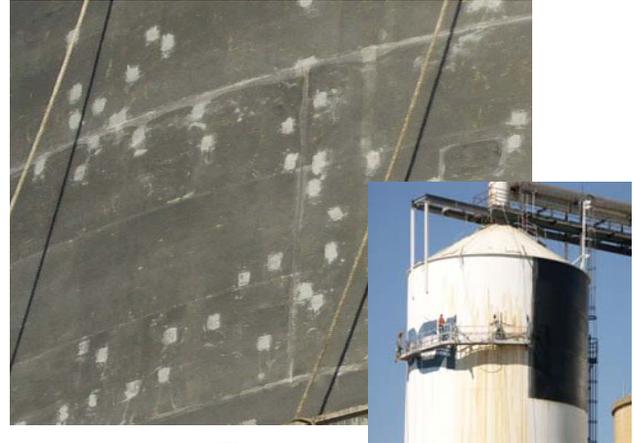
To determine the extent of corrosion, HJ3 performed an ultrasonic thickness test to measure the steel loss throughout the body of the tank. Corrosion to the steel ranged from 30% to 50% steel loss on the upper 50% of the steel tank only. The plant considered replacing the existing steel tank with a new tank at the cost of \$2.5 Million but could not afford the interruption to plant processes and the associated down time costs.

HJ3 engineers developed a carbon fiber solution to repair the top half of the steel tank. The steel substrate was abrasive blasted to clean the steel to white metal, eliminate the existing paint, and profile the steel to a 2-3 mils. 2-inch square thin gauge steel plates were placed over 900 through-holes to create a consistent surface. The steel was then primed with HJ3 PC-200 Primer Coat. After priming 1 to 3 layers of carbon fiber were saturated and boned to the steel to replace the strength lost by the corroded steel sections. To tie the Support Beams to the cat walk into the carbon fiber repair, a carbon fiber shell was fabricated and bonded to the side of the tank walls. Then a polymer concrete was poured to fill the cavity between the carbon shell and the steel I-beam.

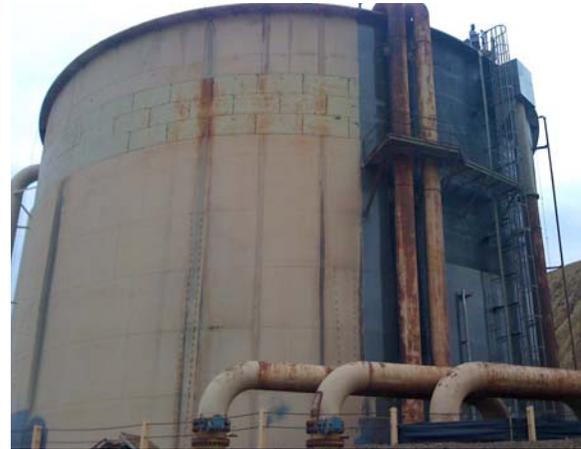
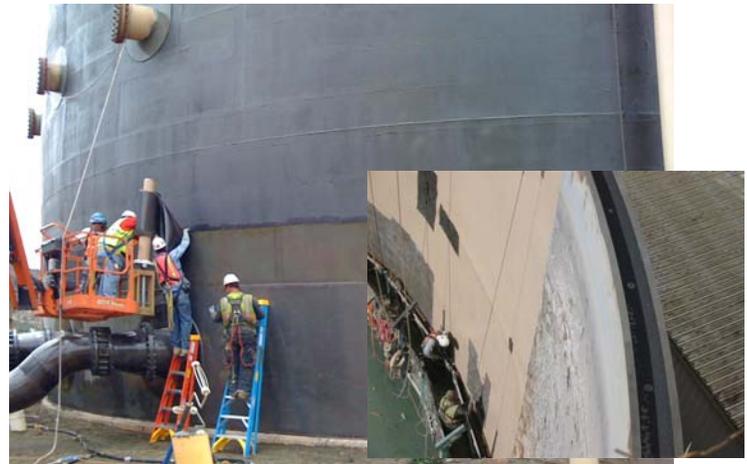
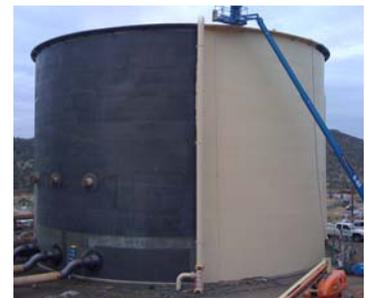
To determine the extent of corrosion, HJ3 performed an ultrasonic thickness test to measure the steel loss throughout the body of the tank. Corrosion to the steel ranged from 25% to 60% steel loss. At these levels, the existing steel was at risk of structural failure. To minimize risk of structural failure, the water levels within the tank were lowered to 50% capacity.

HJ3 engineers developed a carbon fiber solution layering carbon fiber to directly replace the strength lost for each ring of the tank. The bottom 50% of the steel tank was strengthened using one layer of HJ3 CF512 uni-directional fabric. The top 50% of the tank received anywhere from 2 layers to 4 layers of CF516 uni-directional carbon fiber. The system was then coated with a urethane top coat pigmented to match the company's colors and logos. The inside of the tank was blasted and coated to stop the internal corrosion from undermining the remaining steel.
