Axial Confinement of Concrete Columns with Carbon Wrap

Case Study – HJ3 CS200906

Case Study – HJ3 CS200912

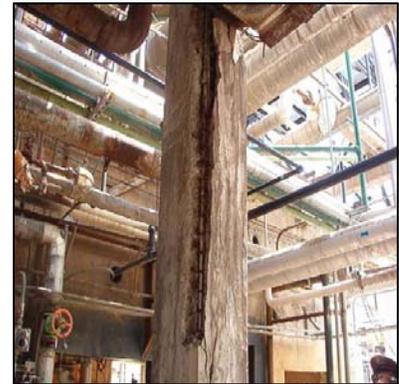
During a plant survey it was shown that reinforcing rebar within the column had deteriorated up to 25% as much of the rebar was completely exposed to the external environment. The resulting damage of the columns and beams compromised the structures fire rating, endangering plant operations and worker safety. Given the extent of the damage, the plant considered three alternatives: replacement, resurfacing of concrete and reinforcement with HJ3's Composite System, and only resurfacing the concrete. The plant chose to resurface the structures with a cement based grout to reestablish the fire rating of the structure and then strengthened the patched area with HJ3's Composite System. The use of HJ3's Composite System was selected to handle shear forces from thermal expansion and contraction and continued vibration that caused the initial damage to the columns

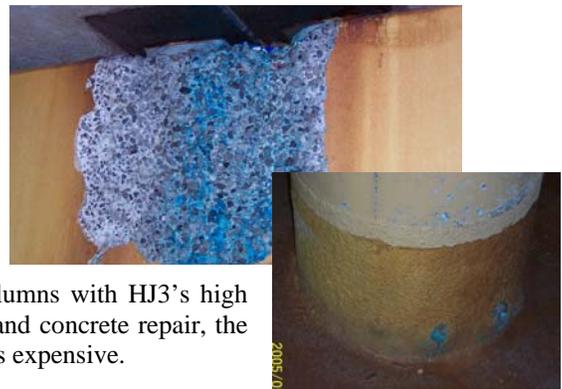
During a plant survey extensive corrosion to both reinforced concrete columns and beams was noted. The problem stems from electrolyte attack of steel re-bar. As the tanks over flow electrolyte floods the basement and pools at the base of the columns. The electrolyte also leaks through the floor of the tanks and pools in the concrete beams. Over time the steel reinforcement will lose 50% to 75% of its strength causing risk of failure. The mine considered two options (1) Re-core new #9 bar 6-inch on center into the existing columns and re-pour concrete to rebuild the columns, or (2) wrapping the columns with HJ3's high strength s-glass system. After attempting the traditional steel and concrete repair, the plant determined that the carbon fiber would be 75% to 80% less expensive.

The columns were first abrasive blasted to remove loose particles and clean the substrate. Corroded rebar were cleaned and treated to prevent further corrosion. Then a 6000-psi grout was used to resurface the columns back to their original shape. After surface preparation, the columns were primed with 10 mils of the HJ3 PC-100 Primer Coat. Then two layers of HJ3's s-glass fabric were saturated with SR-400 Saturating Resin and wrapped around the columns.

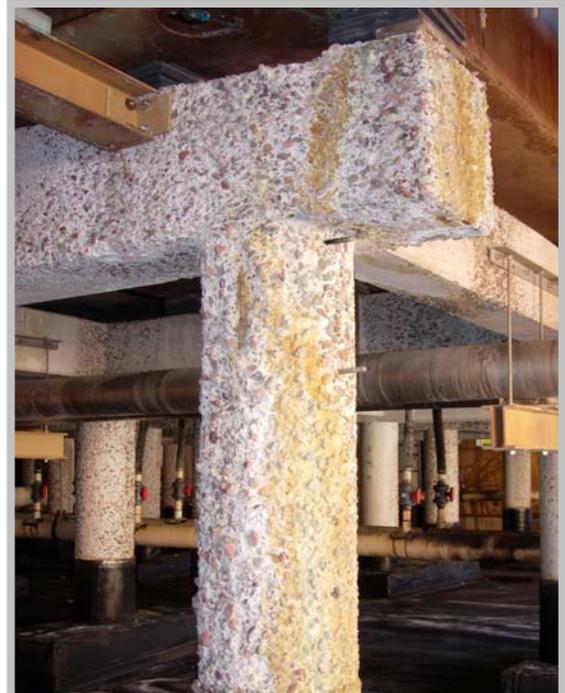
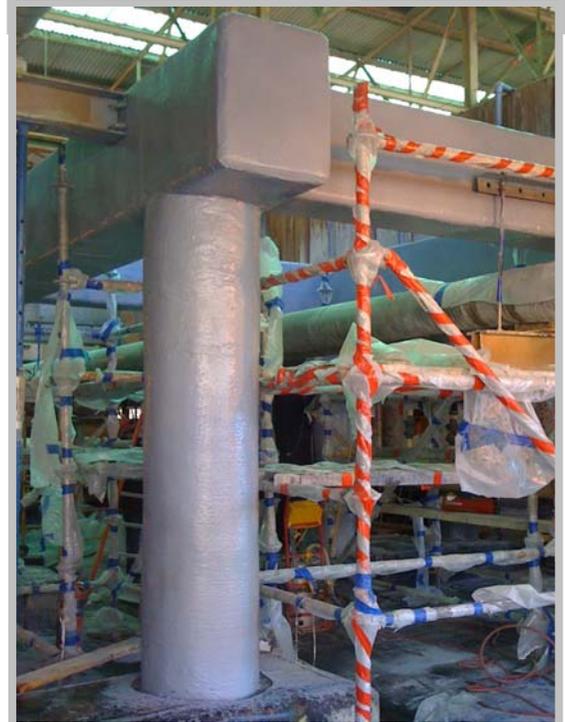
During a plant survey, extensive corrosion to both reinforced concrete columns and beams was noted. The problem stems from electrolyte attack of steel re-bar. As the tanks over flow electrolyte floods the basement and pools at the base of the columns. The electrolyte also leaks through the floor of the tanks and pools in the concrete beams. Over time the steel reinforcement will lose 50% to 75% of its strength causing risk of structural failure. At this facility, the electrolyte penetrated deep within the pours of the concrete surface of both the columns and the beams.

The columns were first abrasive blasted to remove loose particles and clean the substrate down to rough aggregate to thoroughly clean all contaminants out of the concrete substrate. The steel rebar were also cleaned and treated to prevent further corrosion. Next, a quick set 6000-psi grout was used to resurface the columns back to their original shape. After surface preparation and patching, the columns were primed with 10 mils of the HJ3 PC-100 Primer Coat. Then one layer of HJ3's s-glass fabric was saturated with SR-400 Saturating Resin and wrapped around the columns. A final coat of HJ3 HCRC- 511 Epoxy Novolac was installed over the HJ3 reinforcing system.
