## Internal Lining of Man Holes with Carbon Fiber and 120 mil top coat

### Case Study – HJ3 CS200914

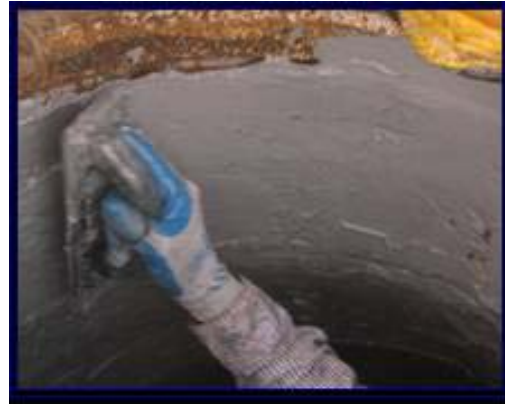
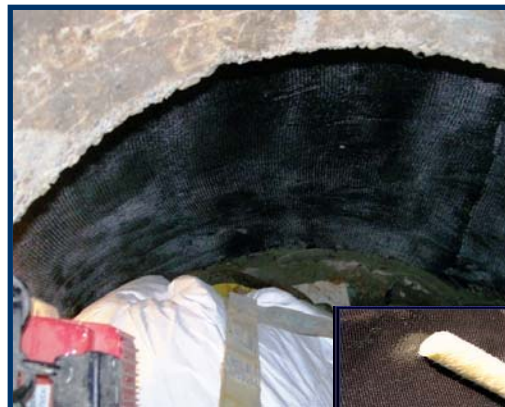
Hydrogen Sulfide from the waste that is processed through the sewer lines can attack the concrete surface of the manholes causing significant corrosion, cracking, and de-lamination of concrete. In addition, manholes experience structural failure caused by external forces such as hydrostatic pressure and soil heaving. In this particular case study, 30 manholes were repaired to mitigate the damages caused by corrosion and external soil pressure.

HJ3 engineers designed a repair that included one layer of CF-512 to provide internal surface tension to resist external soil pressures. The carbon fiber also served to chemically protect the manhole against hydrogen sulfide degradation. The system was installed during the presence of significant moisture and moisture tolerant grouts and primers were used to prepare the substrate. The repairs were completed in 30 days and created a 25% cost savings over standard 120 mil coating systems traditionally used for these repairs. Bond adhesion testing was performed for quality control 90 days after installation and showed a minimum of 300-psi bond strength to the substrate was achieved.
