Introduction

The pulp & paper plant discussed in this case study processes millions of pounds of paper. The concrete flooring slabs and support structures in the plant are exposed to a tremendous amount of impact and live loads due to transportation of material and vibration. As the concrete structures breaks down, cracks are exposed to various chemicals used in the manufacturing process, which corrode and deteriorate the reinforcing steel rebar.

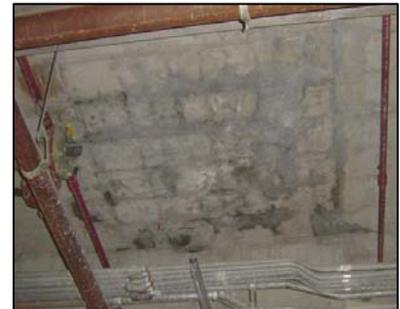
The overhead slab repaired in this cased study was initially damaged from the topside by impact of 5,000 lb rolls of paper that were dropped on its surface. The impact resulted in cracking of the concrete, which propagated under continued loading and vibration. The damage was accelerated by high heat and extreme humidity which created moisture that corroded the steel rebar within the slab. The alternative repair method considered involved the use of steel plates that would be bonded to the underside of the slab with epoxy and anchor bolted. Due to access constraints, obstructions, and cost, the HJ3 carbon system was used in place of the steel plates.
