Axial Confinement of Concrete Columns with Carbon Wrap

Case Study – HJ3 CS200906

Case Study – HJ3 CS200912

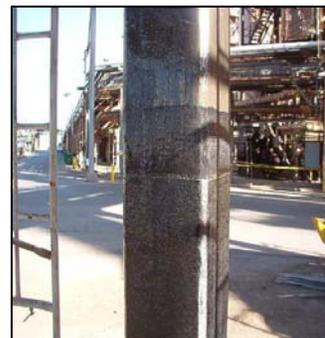
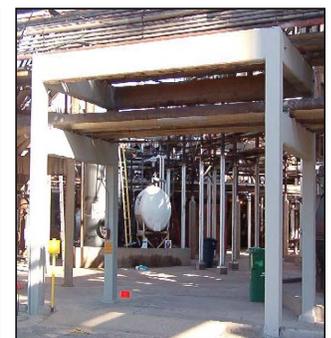
During a plant survey it was shown that reinforcing rebar within the column had deteriorated up to 25% as much of the rebar was completely exposed to the external environment. The resulting damage of the columns and beams compromised the structures fire rating, endangering plant operations and worker safety. Given the extent of the damage, the plant considered three alternatives: replacement, resurfacing of concrete and reinforcement with HJ3's Composite System, and only resurfacing the concrete. The plant chose to resurface the structures with a cement based grout to reestablish the fire rating of the structure and then strengthened the patched area with HJ3's Composite System. The use of HJ3's Composite System was selected to handle shear forces from thermal expansion and contraction and continued vibration that caused the initial damage to the columns

The columns were first wire brushed and cleaned of all loose concrete material. Corroded rebar were then cleaned and treated to prevent further corrosion. Then a 6000-psi grout was used to resurface the columns back to their original shape. After surface preparation, the columns were primed with 10 mils of the HJ3 PC-100 Primer Coat. Then two layers of HJ3's carbon fabric were saturated with SR-400 Saturating Resin and wrapped to the columns.

In total seventeen columns and four beams were repaired and strengthened with the HJ3 Carbon Composite System. The total installation was completed in eight days and resulted in 70% cost savings for the client when downtime and fines were considered. The main advantages of the HJ3 Carbon Composite System were as follows:

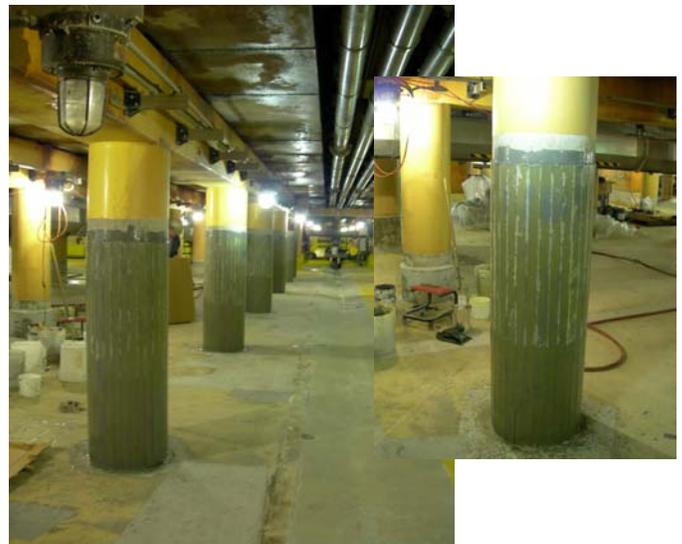
During a plant survey extensive corrosion to both reinforced concrete columns and beams was noted. The problem stems from electrolyte attack of steel re-bar. As the tanks over flow electrolyte floods the basement and pools at the base of the columns. The electrolyte also leaks through the floor of the tanks and pools in the concrete beams. Over time the steel reinforcement will lose 50% to 75% of its strength causing risk of failure. The mine considered two options (1) Re-core new #9 bar 6-inch on center into the existing columns and re-pour concrete to rebuild the columns, or (2) wrapping the columns with HJ3's high strength s-glass system. After attempting the traditional steel and concrete repair, the plant determined that the carbon fiber would be 75% to 80% less expensive.

The columns were first abrasive blasted to remove loose particles and clean the substrate. Corroded rebar were cleaned and treated to prevent further corrosion. Then a 6000-psi grout was used to resurface the columns back to their original shape. After surface preparation, the columns were primed with 10 mils of the HJ3 PC-100 Primer Coat. Then two layers of HJ3's s-glass fabric were saturated with SR-400 Saturating Resin and wrapped around the columns.

In total over 150 columns were repaired and strengthened with the HJ3 Carbon Composite System. The total installation resulted in 75% to 80% cost savings over the traditional steel and concrete repair. The main advantages of the HJ3 Carbon Composite System were as follows:
